UNITED STATES DISTRICT COURT  
WESTERN DISTRICT OF TEXAS  
AUSTIN DIVISION

JON R. DEUTSCH	§	
<b>Plaintiff</b>	§	<b>CIVIL ACTION NO. 1:16-CV-97</b>
VS.	§	
ANNIS ENTERPRISES, INC.	§	
<b>Defendant</b>	§

**COMPLAINT**

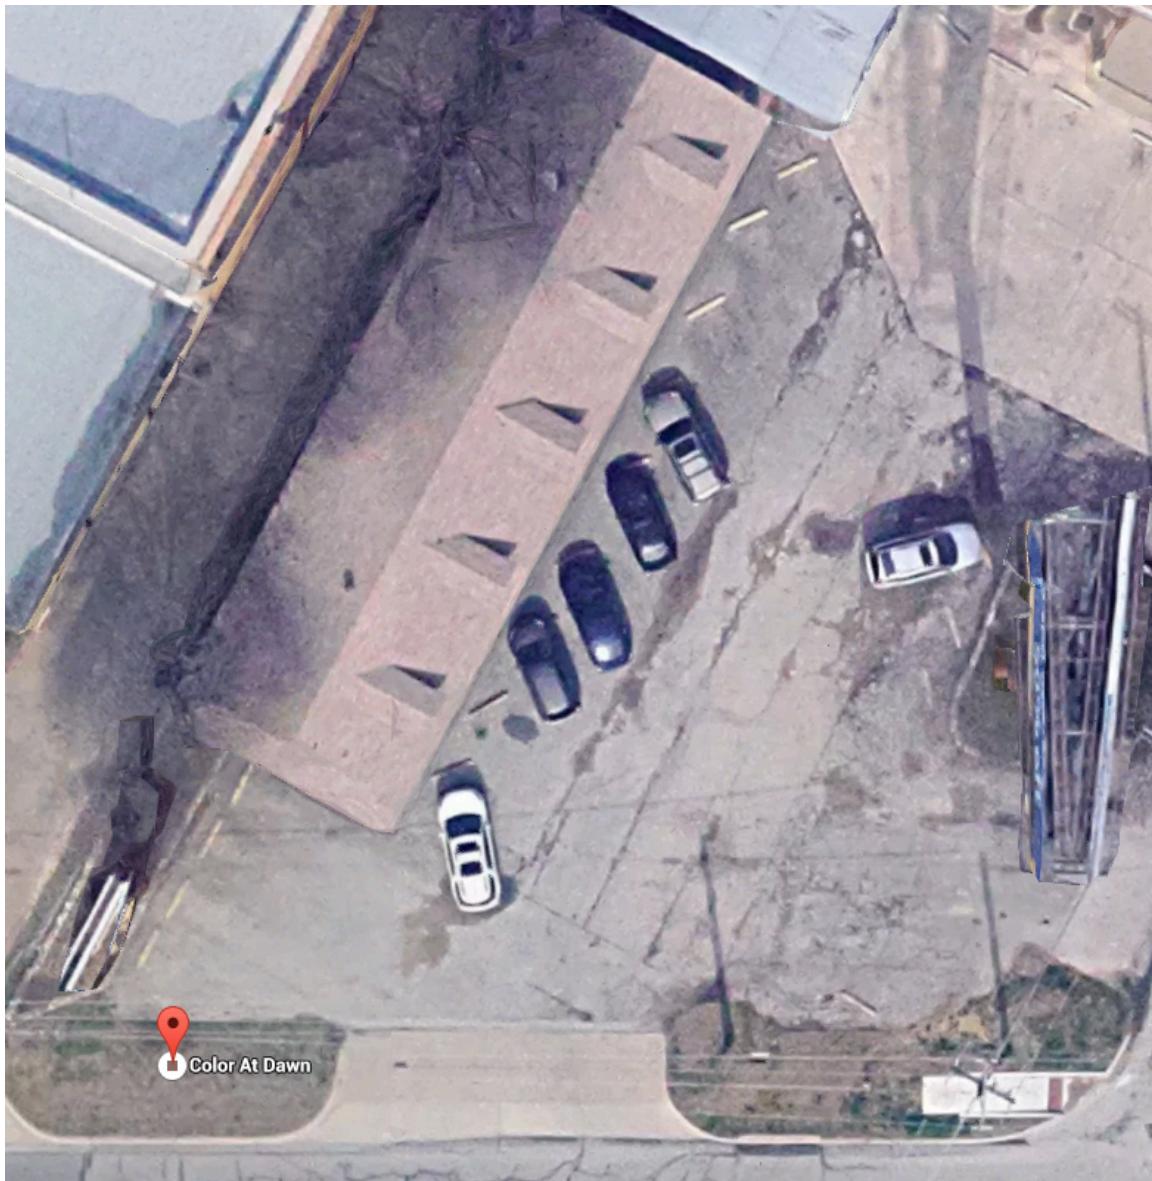
**Fig. 1 - Overhead view of COLOR AT DAWN AUSTIN IN 2015.**

Satellite Images from *Texas General Land Office, Texas Orthoimagery Program, U.S. Geological Survey, 2015*. Note: This property has zero ADA-Compliant Van Accessible Parking Spaces. Under the Americans with Disabilities Act, this business must have 1 ADA-Compliant Van Accessible Parking Space (96" Wide with 96" Side Access Aisle).
